Case Study

Application: Powerplant Repeated condensate pump failures resolved using continuous monitoring data.

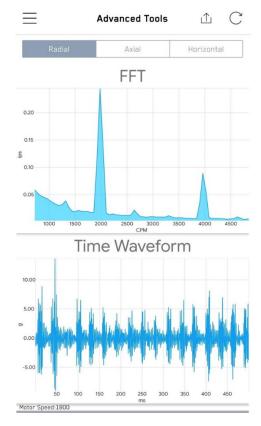
Data retrieved via their wireless Bluetooth® link indicated that a serious vibrational issue had developed. Thermal imaging revealed that the bearing housing was running at an extremely hot 2350, so the bearings were certain to soon fail once again.

i-ALERT vibrational data indicated that failure was once again imminent.

ITT Solutions Engineering took further vibration, flow and pressure measurements and quickly concluded that this was a straight-forward operational issue: the pumps were running way back on their curves. Knowing that low flow situations were a possibility, the company had installed recirculation lines, but they were inadequate because they weren't sized appropriately. In actuality the pumps were about four times larger than they needed to be for this application. And that was the root cause for the repeated bearing and seal failures via excessive thrust loads.

Drop-in replacement pumps were recommended using standard Goulds hydraulics and parts. Custom casings were made to match up to the same suction and discharge locations. The hydraulics are now correct for the service. Because the pumps are right-sized, they are putting the correct loads on the bearings and failures have ceased.
