Application: Bio-fuel Premature bearing failure traced to structural resonance.

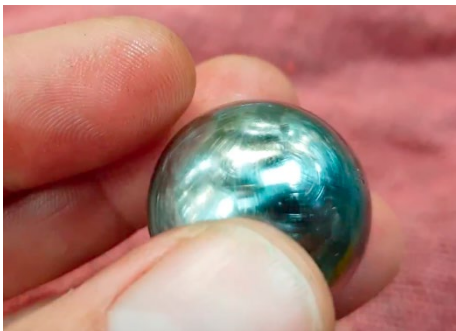
Bearing failure analysis indicated that the balls showed clear signs of skidding. Cage pocket wear was also excessive for the run time, which is consistent with poor ball control. Skidding is due to a lack of sufficient loading, which can be aggravated by certain flow regimes. Replacement with preloaded bearings can solve this problem, but it was decided to investigate the underlying cause.

Many circular scars all over the surface of the ball indicated skidding.

The pump's running speed has now been moved far enough away from the structure's natural frequency so as to no longer excite it. If uncorrected, bearing failures would no doubt have continued to occur. As an extra precaution, preloaded bearings were used in the replacement.
