### Application: Powerplant Repeated condensate pump failures resolved using continuous monitoring data.

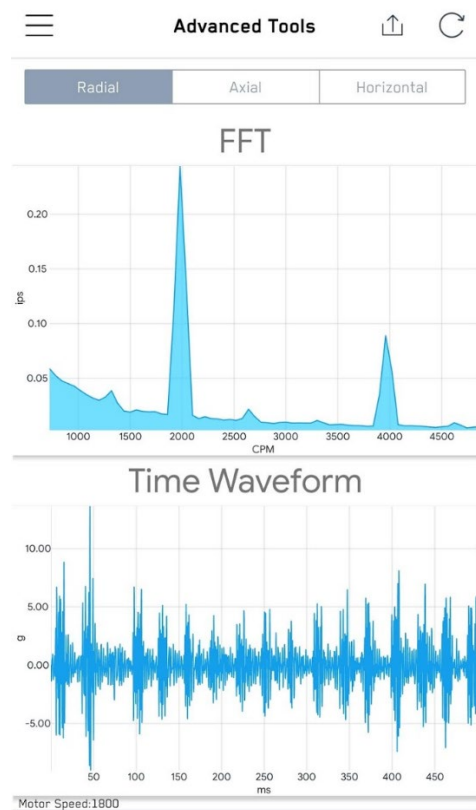
Data retrieved via their wireless Bluetooth<sup>®</sup> link indicated that a serious vibrational issue had developed. Thermal imaging revealed that the bearing housing was running at an extremely hot 2350, so the bearings were certain to soon fail once again.

*i-ALERT2 vibrational data indicated that failure was once again imminent.*

Drop-in replacement pumps were recommended using standard Goulds hydraulics and parts. Custom casings were made to match up to the same suction and discharge locations. The hydraulics are now correct for the service. Because the pumps are right-sized, they are putting the correct loads on the bearings and failures have ceased.

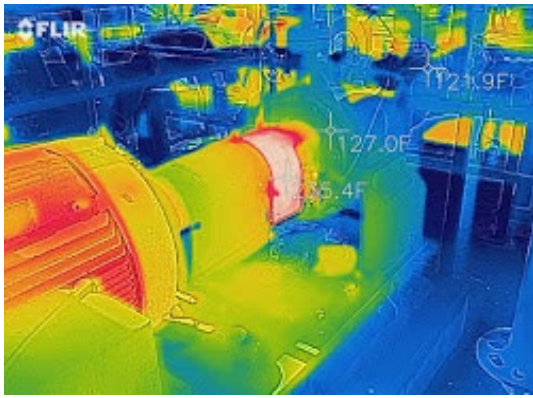
*Thermal imaging revealed that the bearing housing was running extremely hot, making failure imminent.*

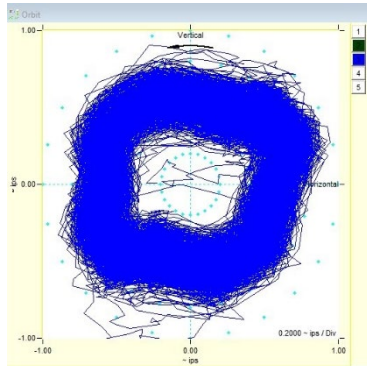
ITT Solutions Engineering took further vibration, flow and pressure measurements and quickly concluded that this was a straight-forward operational issue: the pumps were running way back on their curves. Knowing that low flow situations were a possibility, the company had installed recirculation lines, but they were inadequate because they weren't sized appropriately. In actuality the pumps were about four times larger than they needed to be for this application. And that was the root cause for the repeated bearing and seal failures via excessive thrust loads.

*High density triaxial accelerometer data produced this bearing housing orbit. Its lack of circularity indicated a machine problem structurally as well.*
